Value Engineering Agricultural Plan

Introduction to Value Engineering (VE)

A case study

A case study: Don't judge the soil by its appearance

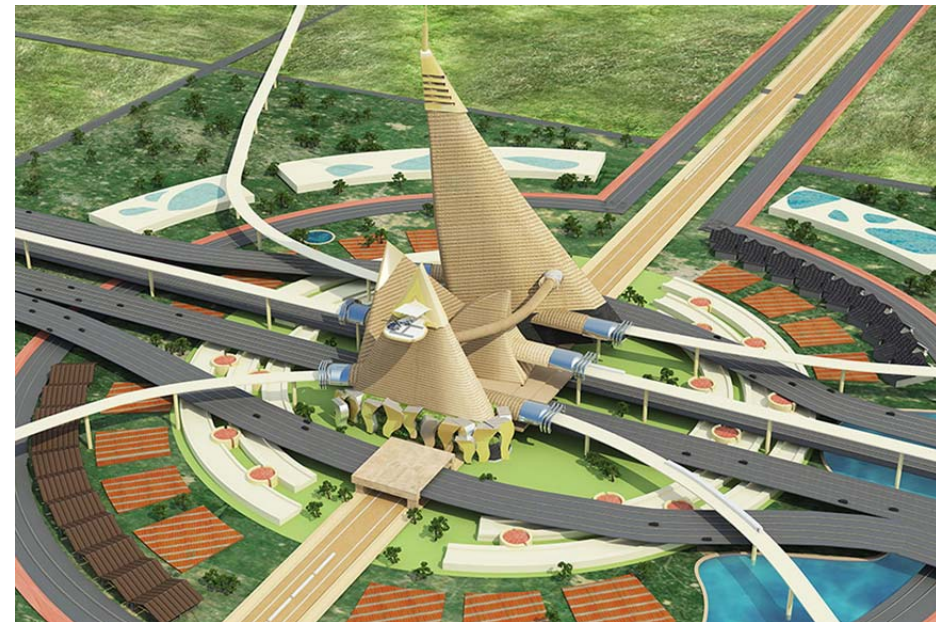
Site Assessment and Soil Evaluation

- The team encountered unexpected soil behavior during road construction in Dholera Smart City.
- Initial judgments about the soil quality were based on color, feel, and local knowledge.
- The team noted the flat ground, lack of vegetation, and fine-grained soil.

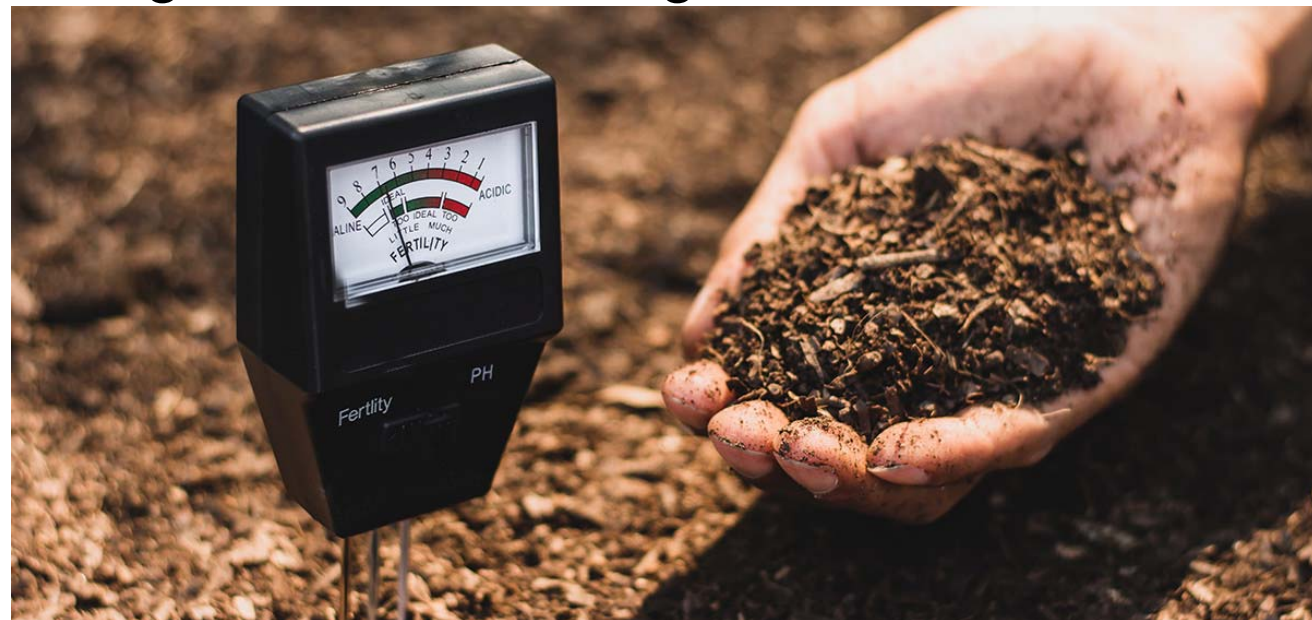
Surprising Soil Discovery

- Surprisingly, the so-called "black cotton" soil was not visible on the surface but found beneath a meter of soil.
- Initial assessment deemed this soil unsuitable for road construction, but the team was not convinced.

- However, a deeper investigation revealed that the problematic "black cotton" soil was hidden beneath the surface. To confirm the suitability of the soil, the team examined local roads and found that road issues were related to the asphalt surface, not the base or subgrade.

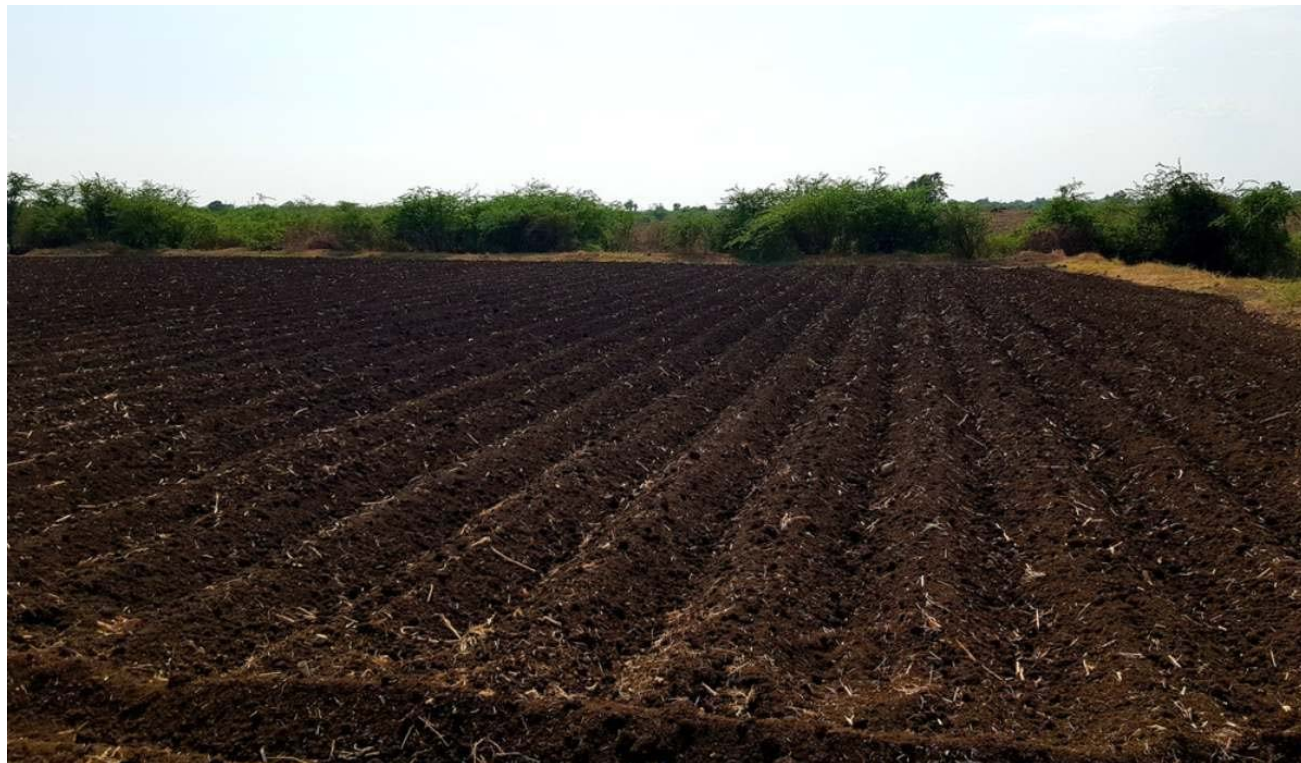
Road Condition Investigation

- To gain a better understanding, the team inspected local roads and found issues in the asphalt wearing course rather than the base or subgrade.
- This observation reinforced the belief that local soil could be suitable for road construction.

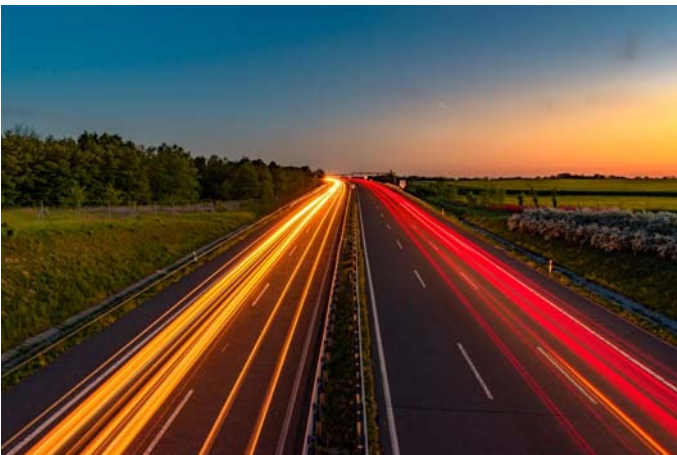
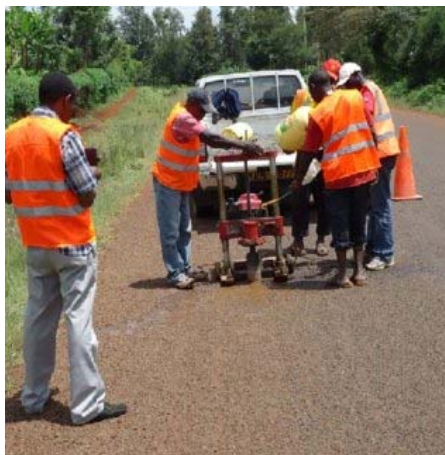
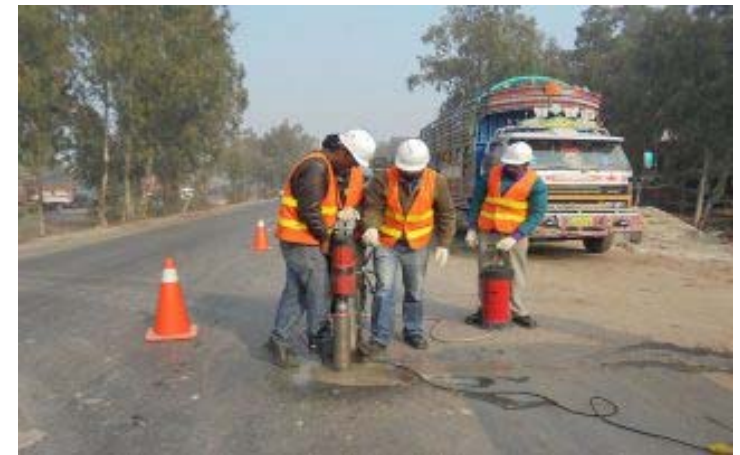
Initial Soil Testing and Hypotheses:

- After setting up a site laboratory, tests were conducted to check field density and observe the soil characteristics.
- Notable factors included the site's proximity to the sea, fluctuating water table, and high groundwater content with chlorides and sulfates.
- Soil properties such as density, color, classification, particle size distribution, and California Bearing Ratio (CBR) were determined.
- Both the surface and the soil at a depth shared similar properties.

- Subsequent soil testing and analysis, considering the soil both as strata and material, indicated that the soil was weak due to fluctuating water levels and unsuitable water quality but could be used effectively in road embankments after compaction.
